# ANALYTICAL STUDY OF THE BRICK TILES USED IN MUGHAL'S AND LATER PERIODS IN THE HISTORICAL SITES OF PUNJAB PAKISTAN (A CASE STUDY OF AKBARI MAHAL, AKBARI GATE AND ROYAL KITCHEN LAHORE FORT)

## Abstract

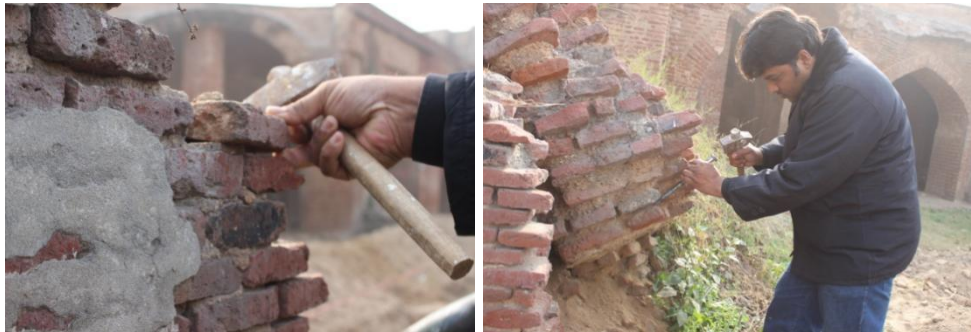
*Figure 1 & 2: Extraction of Sikh Period Brick Tile Specimens in the Left Figure and Mughal's Period in the Right Figure*

The material was removed, avoiding to harm the building fabric, through the assistance of the sludge hammer and chisel while encountering with Mughal and British periods masonry work. The brick specimens were taken out from that section of the structures, which was already required the repair/renovation process. The specimens of the brick tiles of Sikh era and Post-Independence era were removed without the use of chisel and hammer. Each of the buildings i.e. Akbari Gate, Akbari Mahal and Royal Kitchen had three brick tiles specimens in each period, i.e., Akbari Gate, Akbari Mahal and Royal Kitchen and were packed carefully in three large zipper polythene bags each. A total of 36 specimens of the brick tiles were gathered as shown, (Figure-1-6).

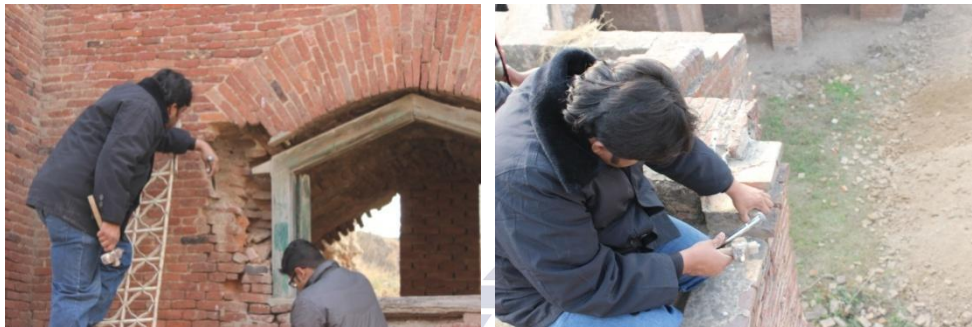
*Figure 3 & 4: Extraction of British Period Brick Tile Specimens in the Left Figure and Post-Independence Period in the Right Figure*

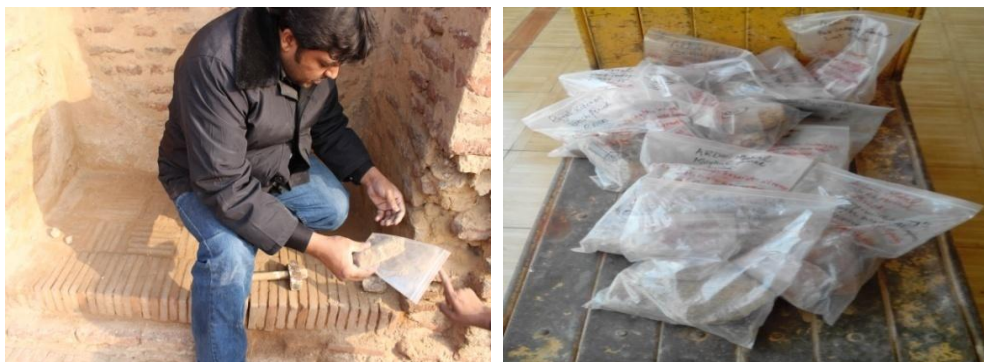
*Figure 5 & 6: Packing of British Period Brick Tile Specimens in the Left Figure and Transportation of all the Packed Specimens to the Laboratory in the Right One*

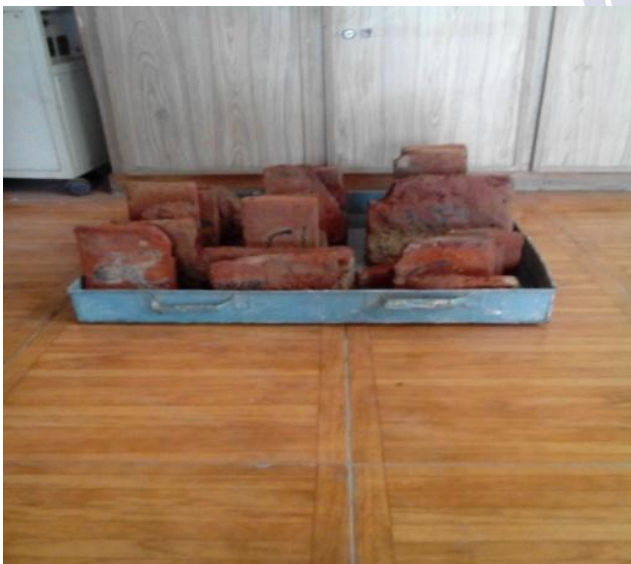
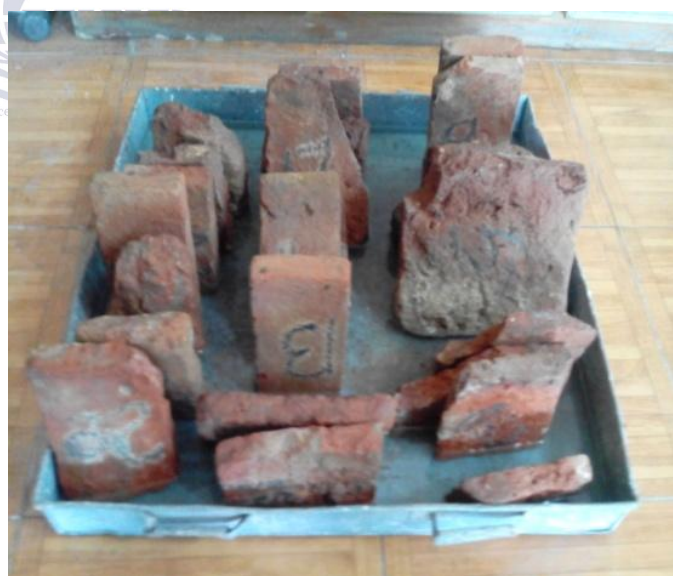
*Figure 7&8: Brick Tile Specimens Kept in the Laboratory for Efflorescence Test*

The water absorption of all the brick tiles which had been checked was put in a large dish of tin in a

well-ventilated room at 25 C to 30 C, lying upright. All the tiles were soaked to a depth of 2.5 cm in distilled water. The bricks absorbed the entire water in two days. An equivalent amount of further distilled water was added and another drying period was offered to ensure reliable results. The given clay brick tiles specimens were then be tested on efflorescence.

**Slight:** It was noted that the coverage of not more than 10 percent of the areas of the bricks of the period of Mughal, British Period and Post-Independence period was observed. It implies it was a small efflorescence on these specimens.

**Moderate:** There was a 50 per cent covering of heavy deposits over the brick tiles of the Sikh period. It signifies that it was a moderate efflorescence on these specimens.

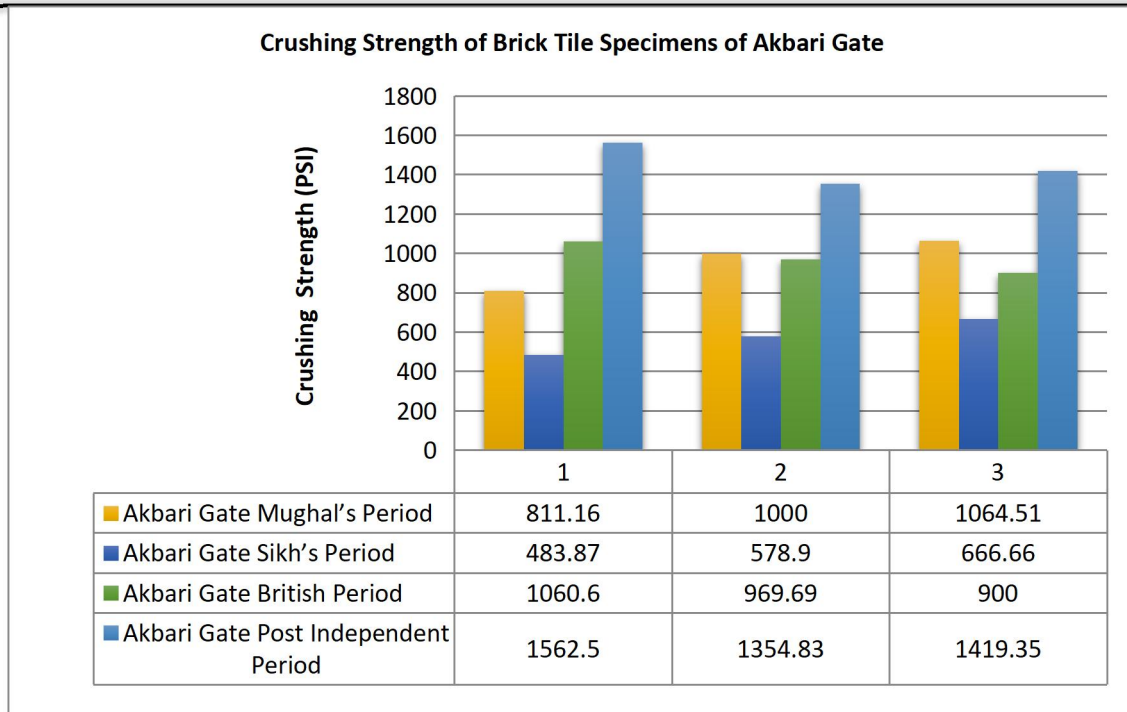
Figure 9: Crushing Strength of Brick Tile Specimens of Akbari Gate

**Table 1 Crushing Strength of Brick Tile Specimens of Akbari Gate**

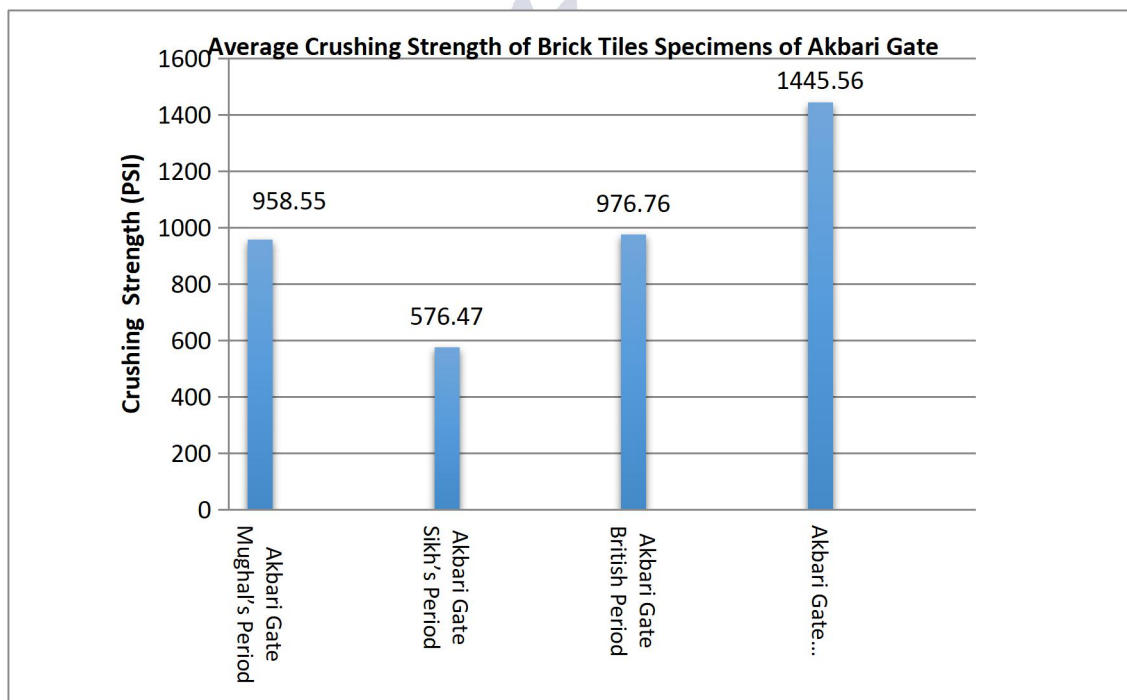
Figure 10: Average Crushing Strength of Brick Tiles Specimens of Akbari Gate

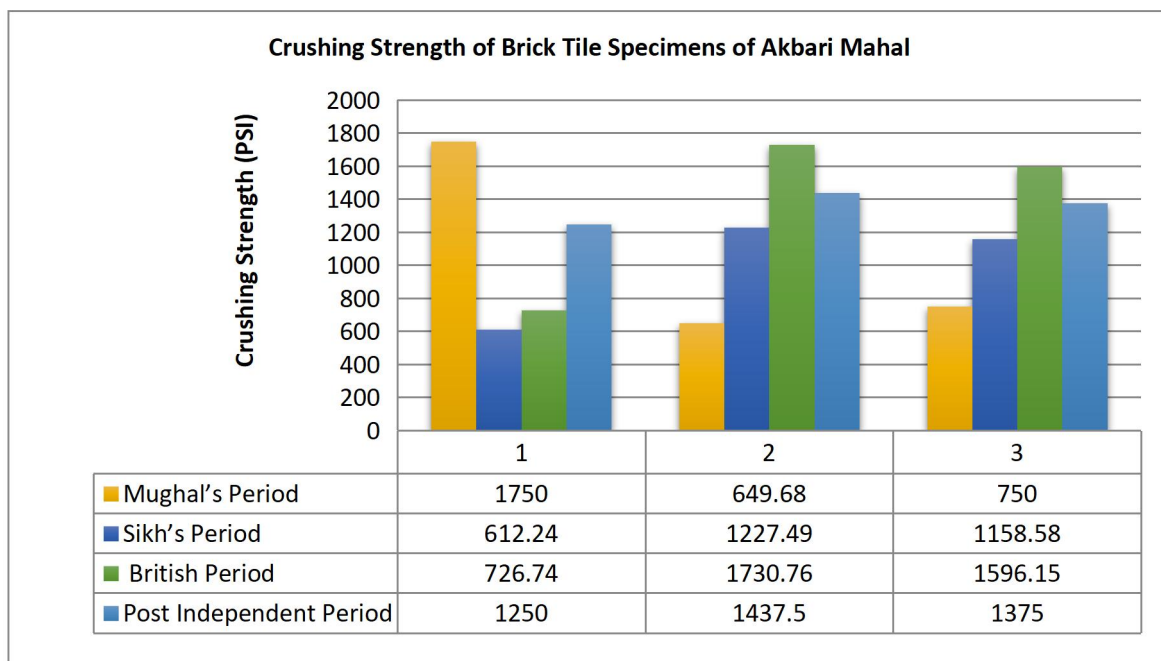
Figure 11: Crushing Strength of Brick Tile Specimens of Akbari Mahal

Table 2 Crushing Strength of Brick Tiles Specimens of Akbari Mahal

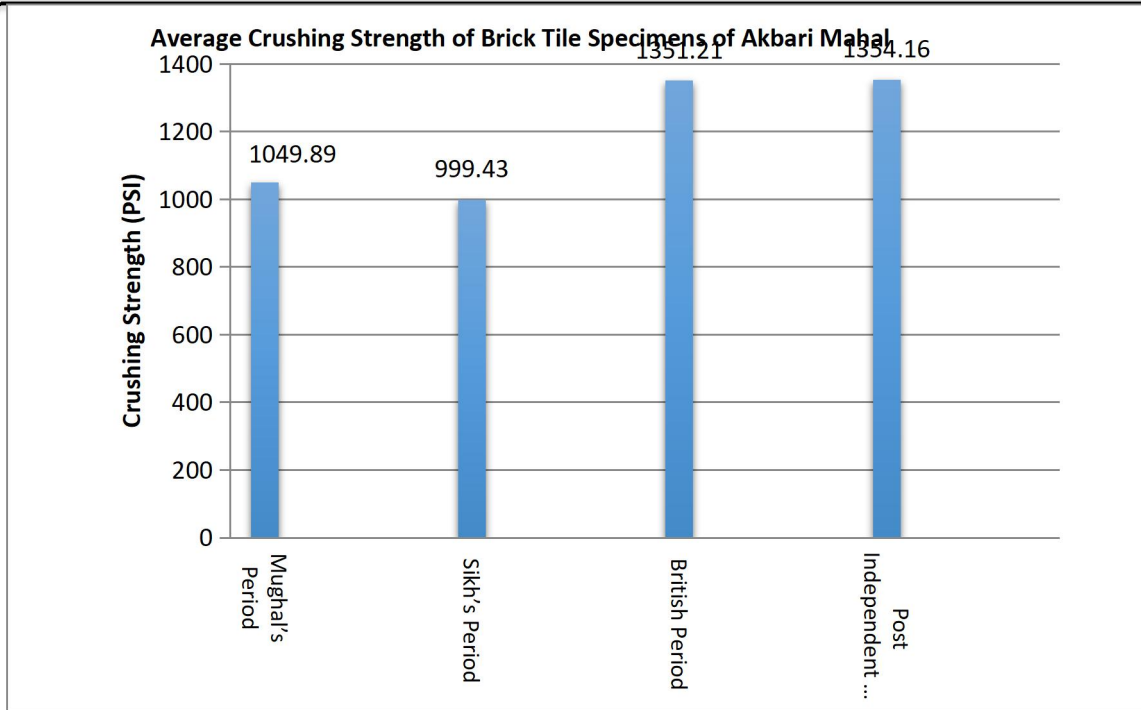
Figure 12: Average Crushing Strength of Brick Tile Specimens of Akbari Mahal

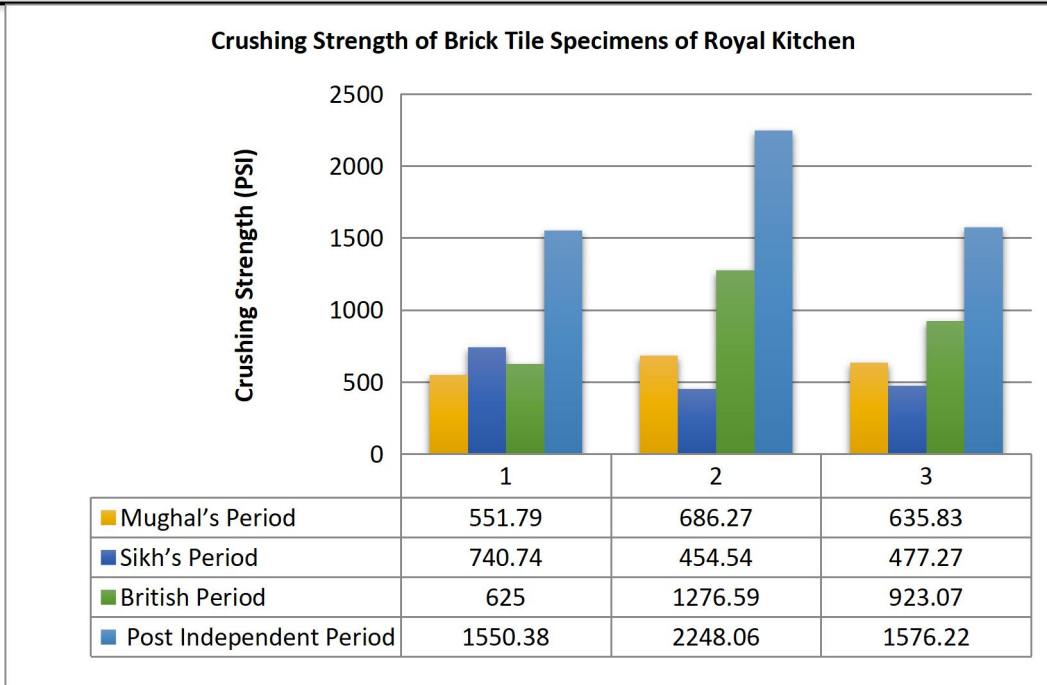
Figure 13: Crushing Strength of Brick Tile Specimens of Royal Kitchen

Table 3 Crushing Strength of Brick Tile Specimens of Royal Kitchen

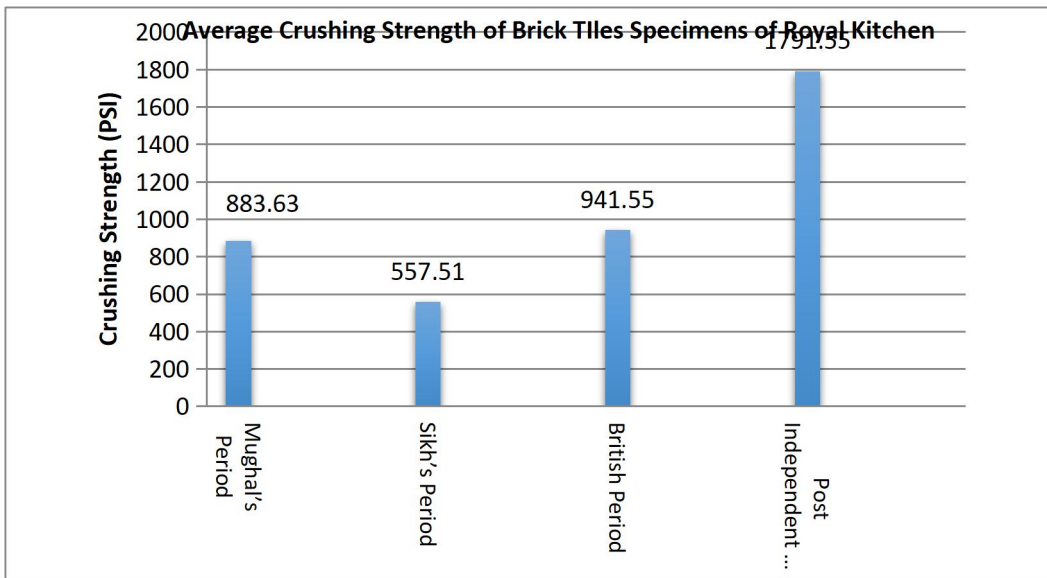
Figure 14: Average Crushing Strength of Brick Tiles Specimens of Royal Kitchen

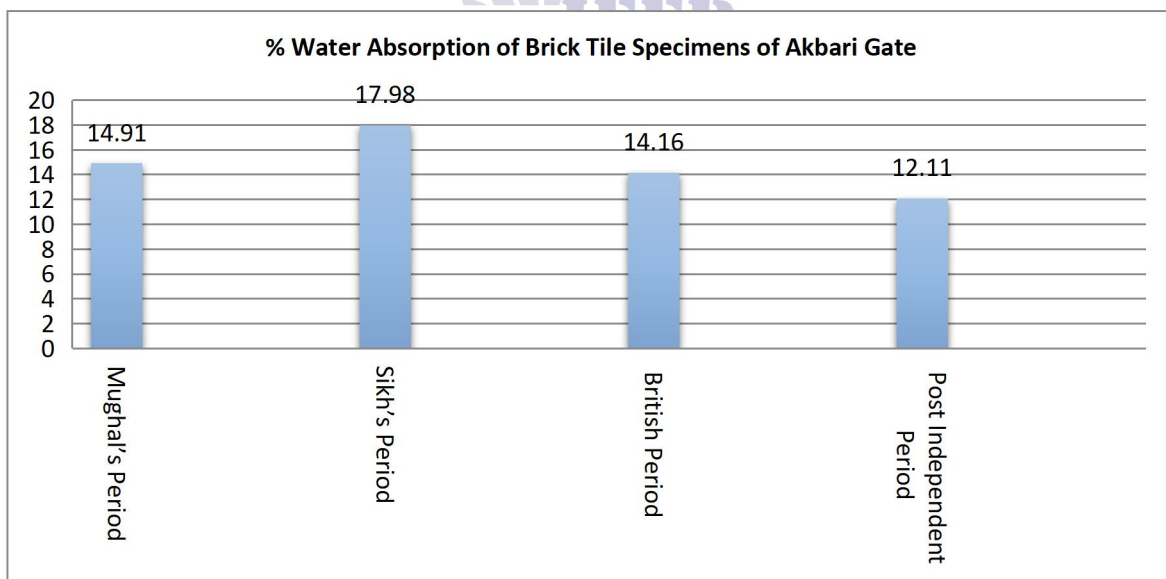
Figure 15: % Water Absorption of Brick Tile Specimens of Akbari Gate

Table 4: %Water Absorption of Brick Tile Specimens of Akbari Gate

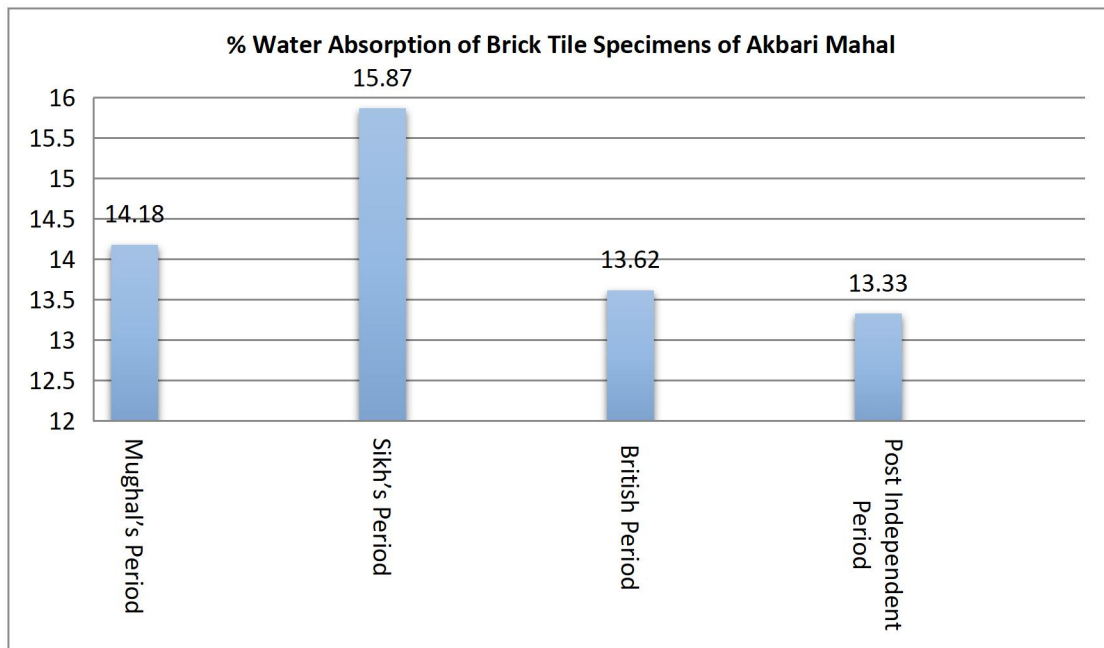
Figure 16: % Water Absorption of Brick Tile Specimens of Akbari Mahal

Table 5: %Water Absorption of Brick Tile Specimens of Akbari Mahal

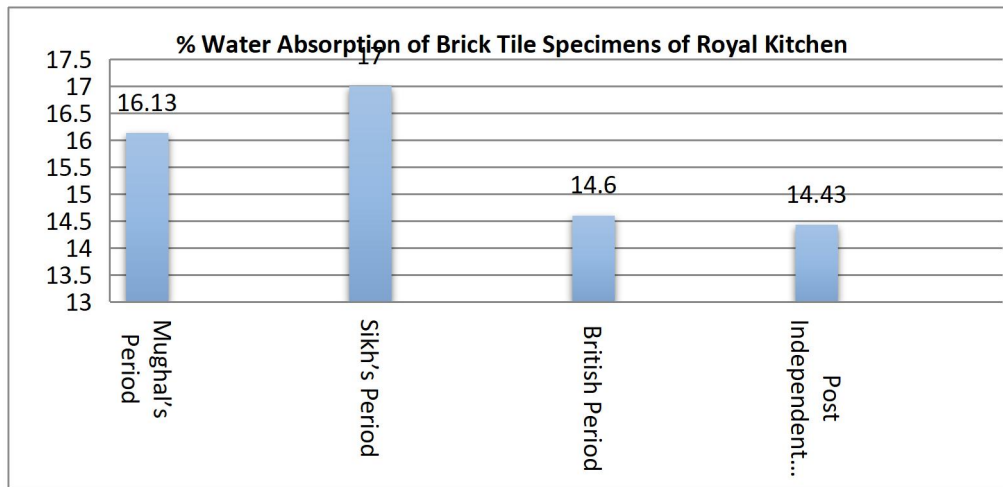
Figure-17: % Water Absorption of Brick Tile Specimens of Royal Kitchen

Table 6: %Water Absorption of Brick Tile Specimens of Royal Kitchen

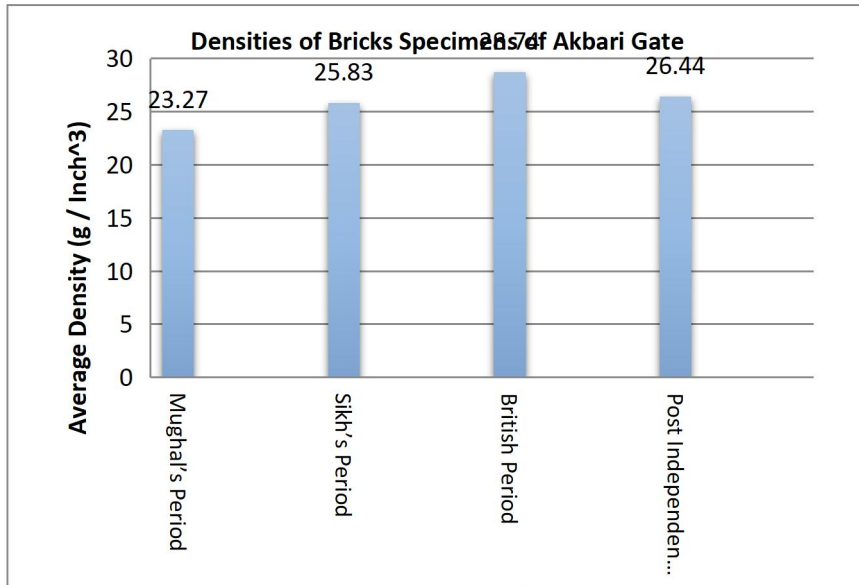
Figure-14: Densities of Brick Tile Specimens of Akbari Gate

Table-7: Densities of Brick Tile Specimens of Akbari Gate

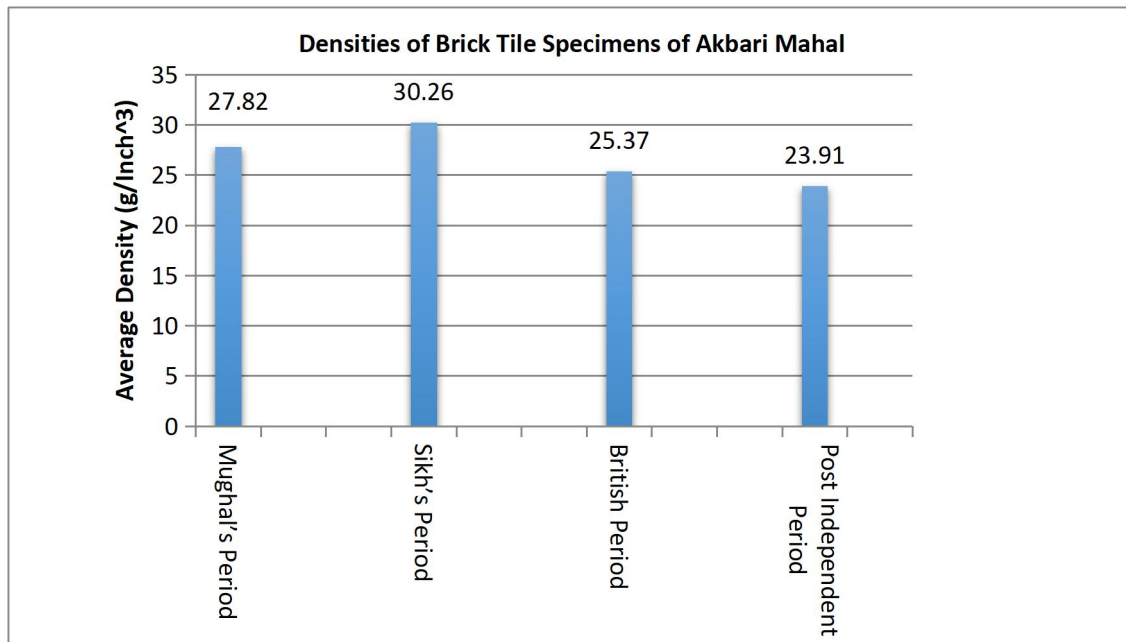
Figure 19: Densities of Brick Tile Specimens of Akbari Mahal

Table 8: Densities of Brick Tile Specimens of Akbari Mahal

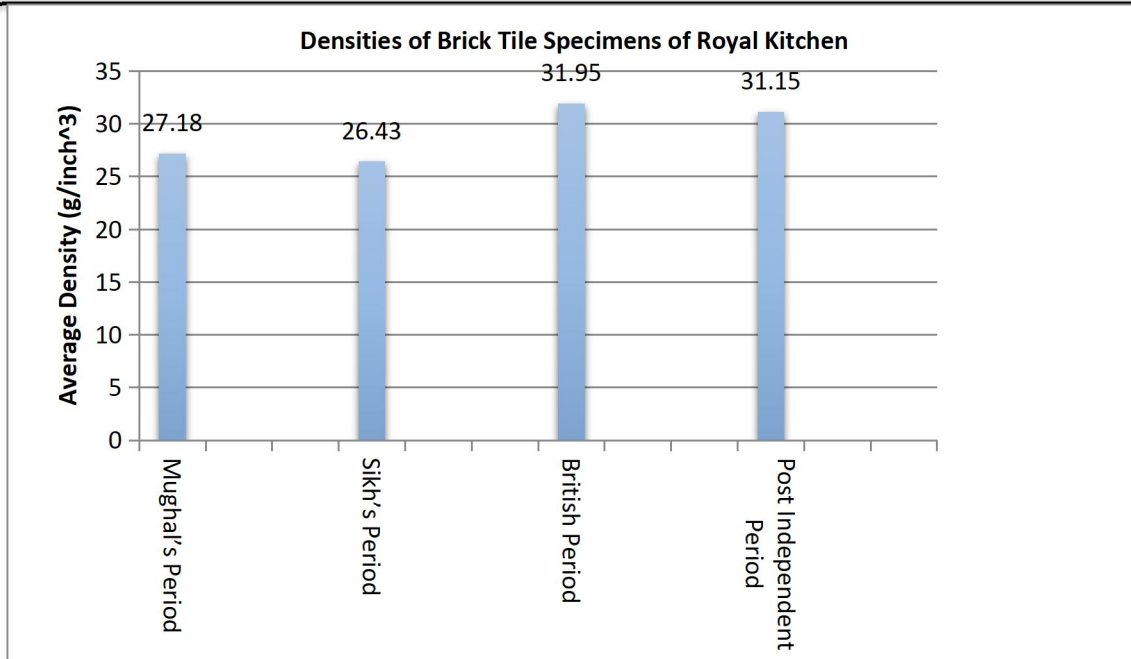
Figure 20: Densities of Brick Tile Specimens of Royal Kitchen

Table 9: Densities of Brick Tile Specimens of Royal Kitchen

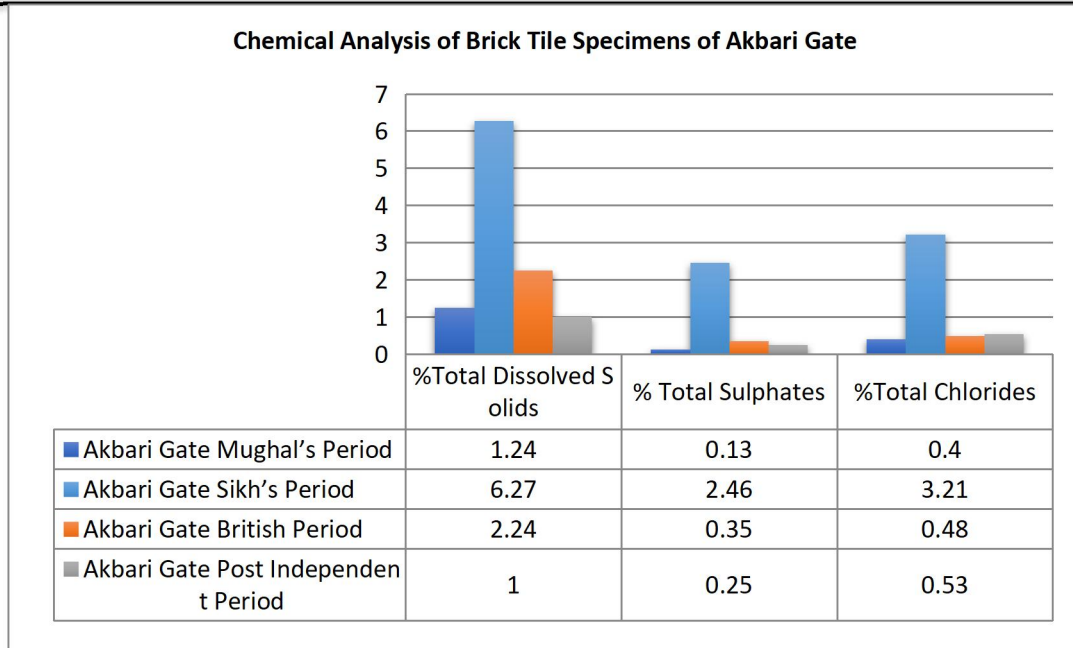
Figure 21: Chemical Analysis of Brick Tile Specimens of Akbari Gate

Table 10: Chemical Analysis of Brick Tile Specimens of Akbari Gate

The total dissolved solids (TDS), sulphates, and chlorides are comparatively high in the brick tiles from the Sikh period. This indicates that the clay selected for brick manufacturing during the Sikh period contained a high concentration of sulphates and that no systematic testing or assessment of clay properties was carried out prior to brick tile production. Although Mughal period brick tiles collected from Akbari Gate also exhibit elevated chloride content, the bricks from the Sikh period show exceptionally high chloride levels exceeding 3% which is far above the generally accepted maximum limit of 0.2% for chlorides in masonry materials (ASTM C67, 2023; Neville, 2011).

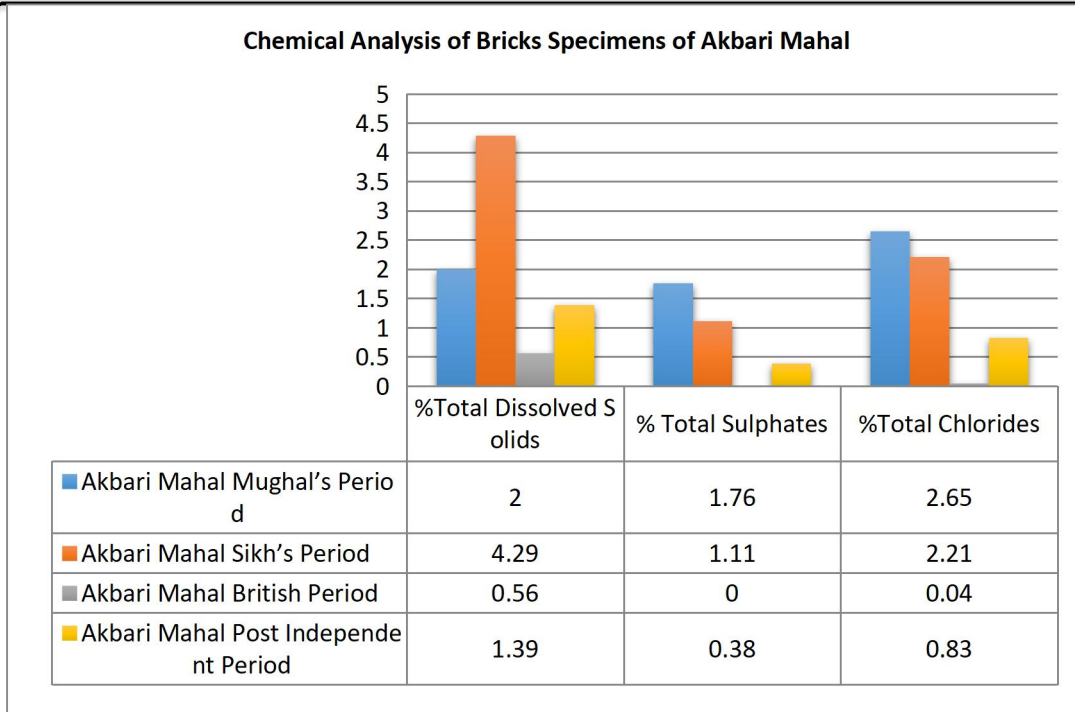
Figure 22: Chemical Analysis of Brick Tile Specimens of Akbari Mahal

Table 11: Chemical Analysis of Brick Tile Specimens of Akbari Mahal

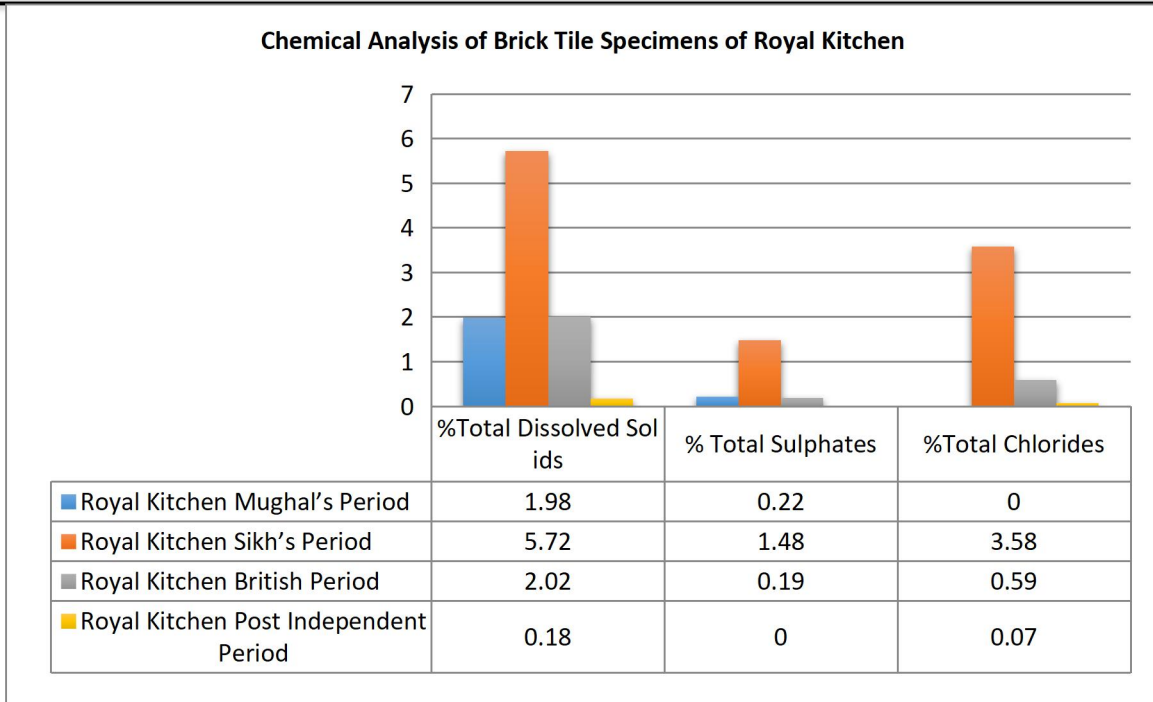
*Figure 23: Chemical Analysis of Brick Tile Specimens of Royal Kitchen*

Table 12: Chemical Analysis of Brick Tile Specimens of Royal Kitchen
